Flooding and Water Quality Evidence Report

for Fawkham Neighbourhood Plan

Fawkham Neighbourhood Plan Steering Group February 2023

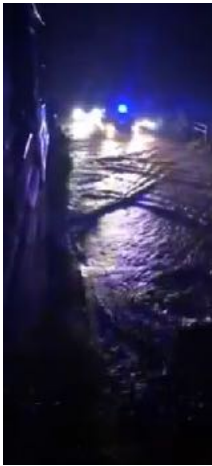
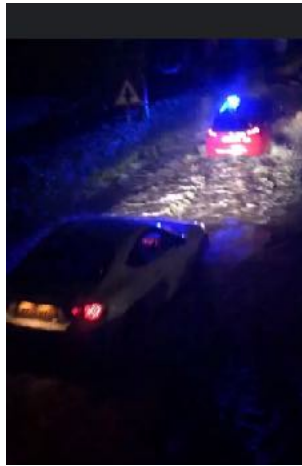
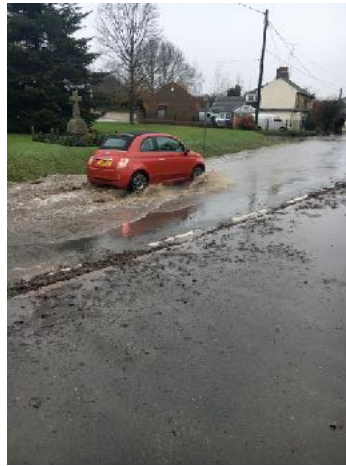
Four properties were flooded internally in this area on 10th June 2019; one family were required to move out of their home for repairs to be made, and one property's oil tank was damaged, resulting in leakage of oil. This flooding was as a result of surface water runoff, which is understood to have led to hydraulic overload, coupled with blocked gullies¹². The Environmental

Photographs show (left, centre) emergency response vehicles on the night of the flood of 10th June 2019 and (right) flooding December 2019

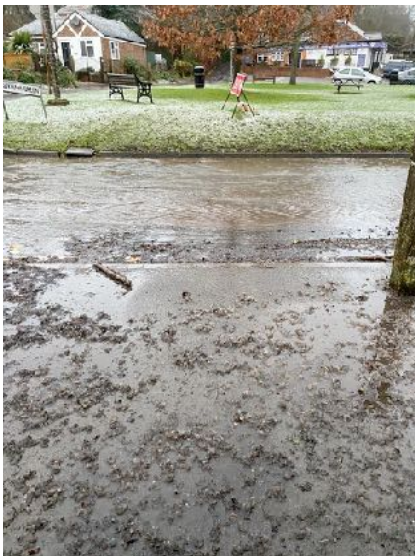
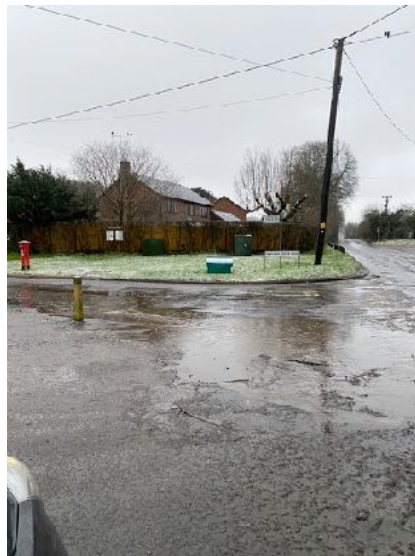
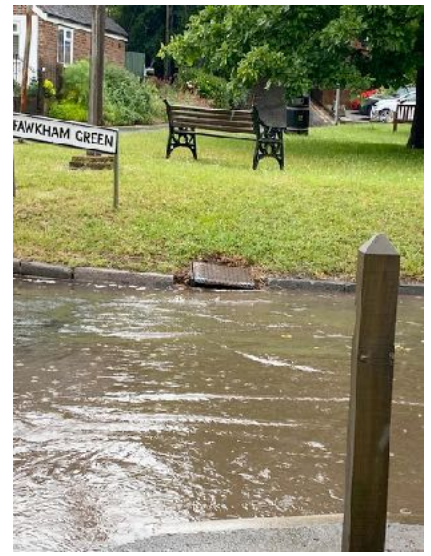
Subsequent CCTV surveys by KCC established that the drainage system here runs south, against the natural flow, to the soakaway on Fawkhams Green Road. A break in the pipework was found and replaced with a new length, and the soakaway was cleansed (January 2021). This has been observed to have resulted in an improvement in the time taken for the water to drain. However, the carriageway continues to become flooded across its full width after heavy or persistent rain, likely due to hydraulic overload, as shown in the photographs below. The drains become blocked with silt and require reporting to KCC on a regular basis.

Photographs showing the village green area, (left and centre) January 2021 - with debris showing

extent of flood width - and (right) June 2021. These are after the repair work was carried out.

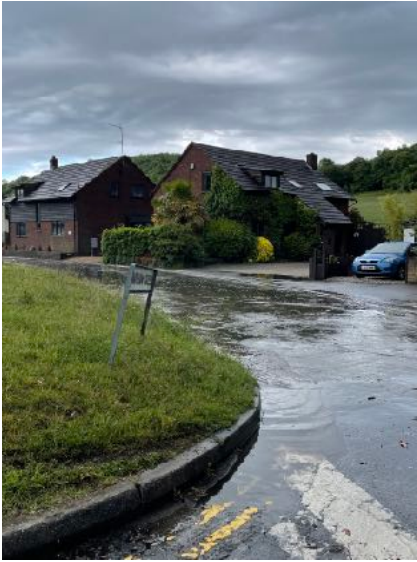
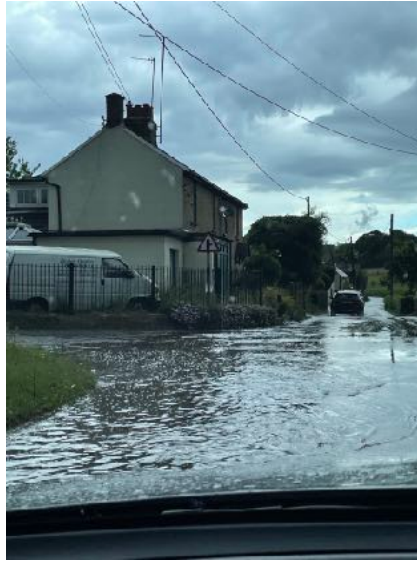
Photographs above show the village green area, in May 2022, showing typical flooding of the carriageway following rain.

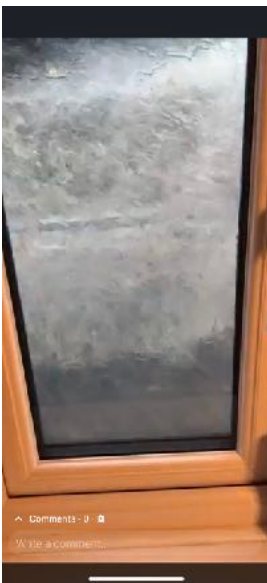
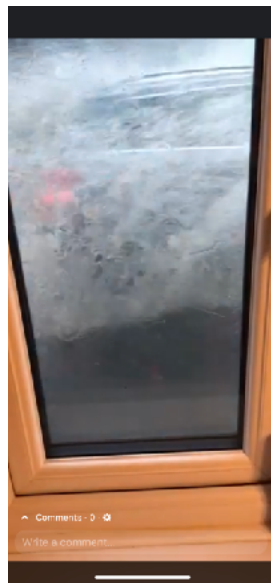
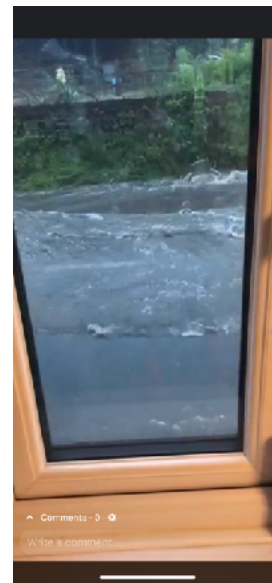
Photographs below show the effect on a property's ground floor window of a car passing it on the flooded Valley Road close to its junction with Michaels Lane in the Fawkham Green area, August 2022.

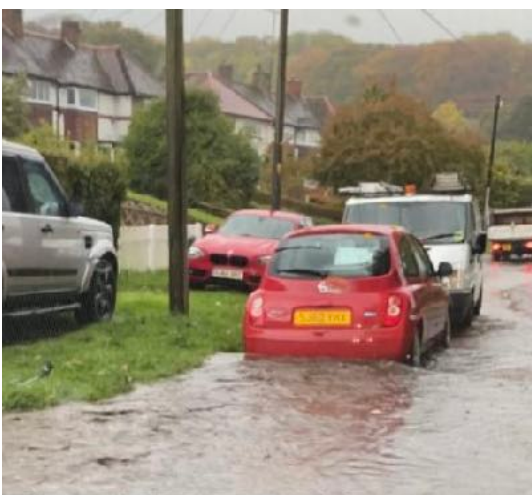
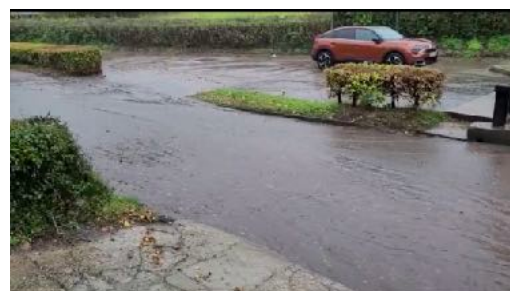
Photographs below show (left) Fawkham Green Road close to the junction with Valley Road, and (right) Valley Road close to the junction with Michaels Lane, October 2022

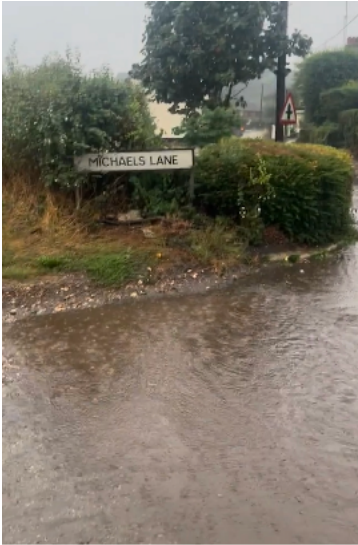
Photograph below shows flooding at the junction of Michaels Lane with Valley Road, August 2022.

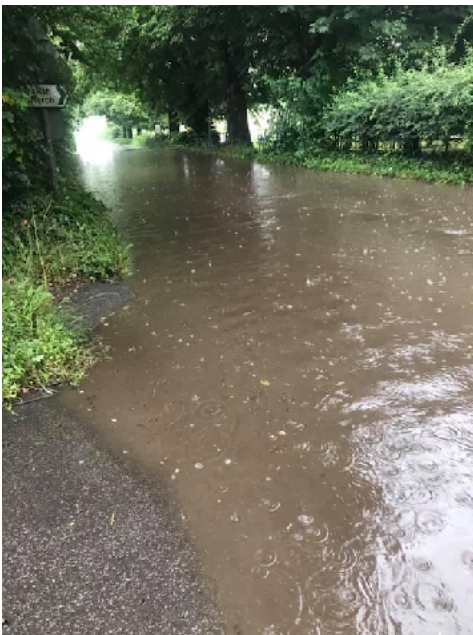
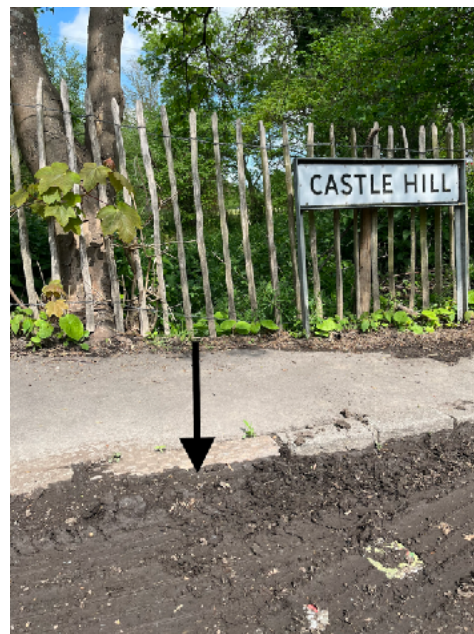
Flooding issues also occur across the full width of the carriageway from Castle Hill north to the boundary with Longfield. KCC's records show eight reports of flooding at the Castle Hill junction with Valley Rd/Fawkham Road over the six year period from July 2017 to July 2022. This is likely caused by the surface water running down Castle Hill joining with that running along the valley floor. There is a pond at this junction which is used for capturing surface water from Castle Hill, although the gullies leading to it are frequently blocked with flints, other stones and silt.

Photographs below show (left) surface water flooding on Valley Road, close to Baldwins Green/ the junction with Castle Hill, April 2021 and (right) blocked gully leading to the drainage pond, indicated by the black arrow, September 2022

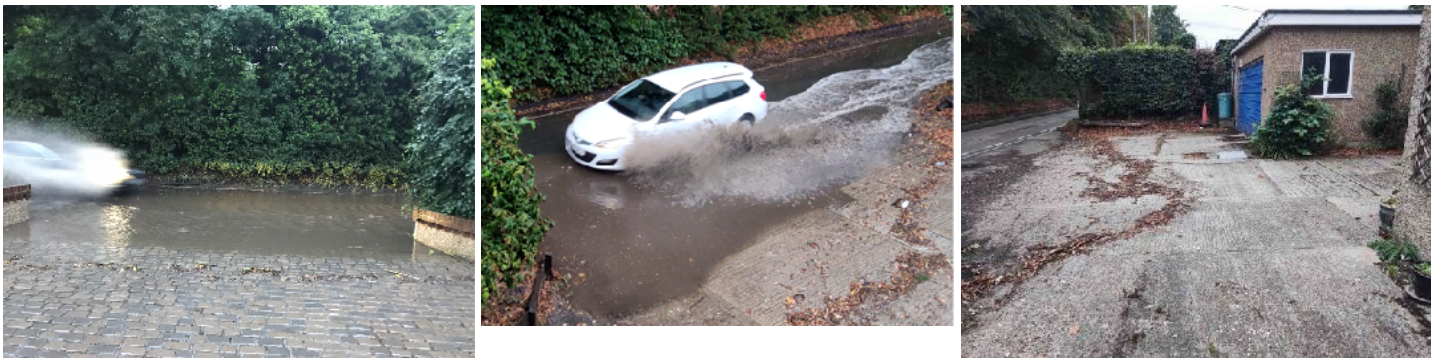
Further flooding issues have resulted from repeated resurfacing of the lane, leading to the carriageway surface being raised above the entrance to driveways of properties on Valley Road to the north of the school. Repeated pluvial and sewer flooding have both occurred at this location. A 300m section of the road at this location was re-profiled by KCC in October 2021, with a kerb laid 40mm above the carriageway surface to prevent water running from the Valley Road into the adjacent properties. However, this issue is likely to reoccur in the future, and occur at other locations, as the carriageway surface receives further layers during resurfacing work, meaning KCC will need to install further kerbs to the carriageway and/or raise kerbs.

Photos above show surface water flooding of Valley Road in this area (left, June 2019 and centre, August 2022) the “tide mark” of debris following water overspilling the new kerb (right, August 2022)

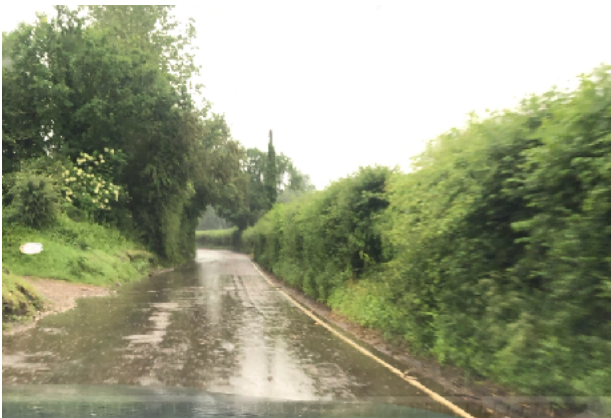
Flooding issues occur across the full width of the carriageway south of Castle Hill, shown in the photo below (June 2019)

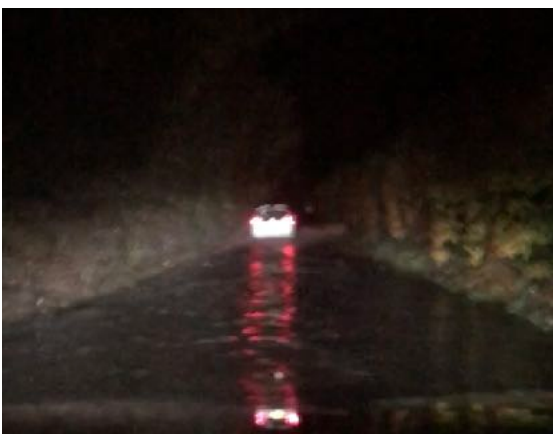
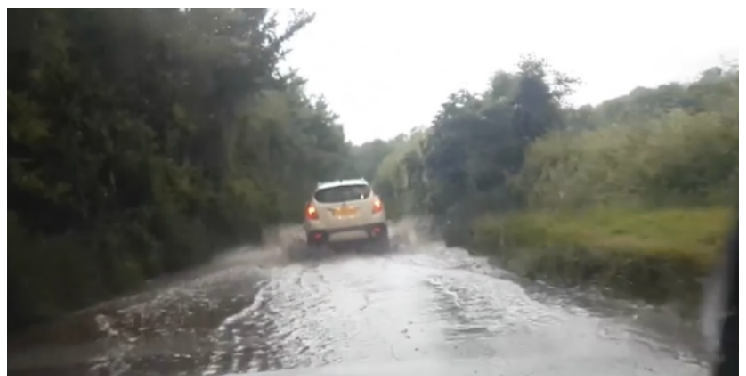
and south of Pennis Lane (left, June 2019) and (right, November 2018).

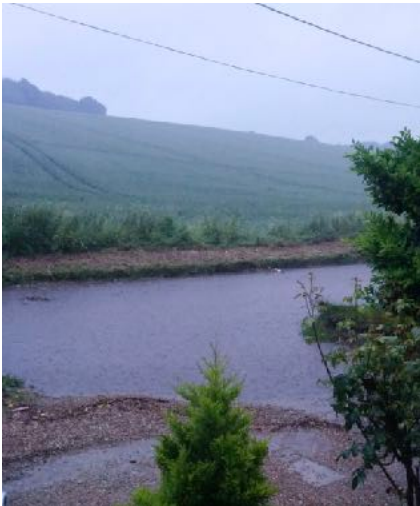
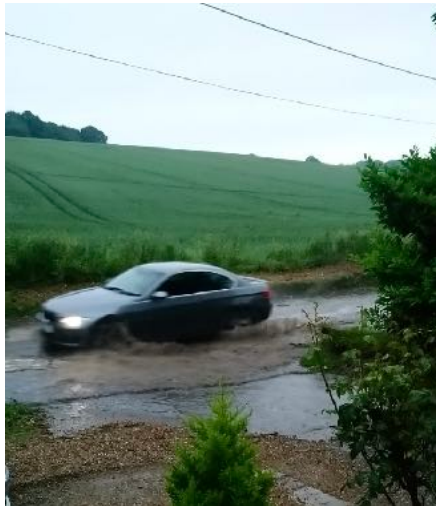
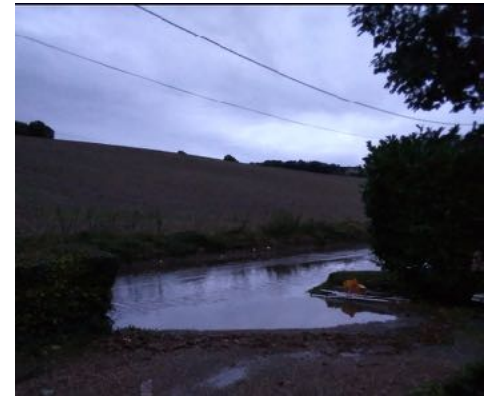
Flooding of the full width of the carriageway also occurs in this area. There are no drainage assets north of Castle Hill for c.1.13km, until the lane reaches Longfield, within Dartford Borough.

Photographs below show this location in (left - right) June 2019, June 2020 and October 2021

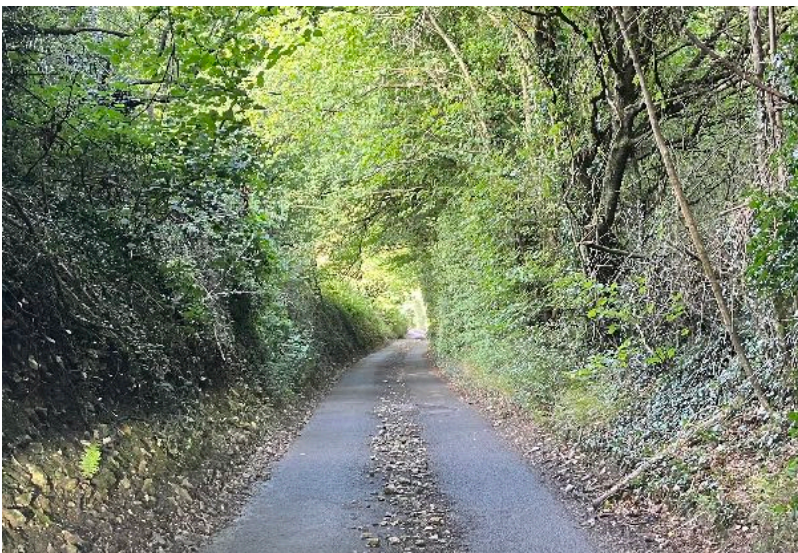
Flints, silt and debris are regularly washed down the valley sides and banks and onto the carriageway by surface water runoff, including on Valley Road, Manor Lane and Crowhurst Lane. This represents a danger to road users, and also causes blockages to the drainage assets.

Photo: Crowhurst Lane showing flints washed into the carriageway, July 2022

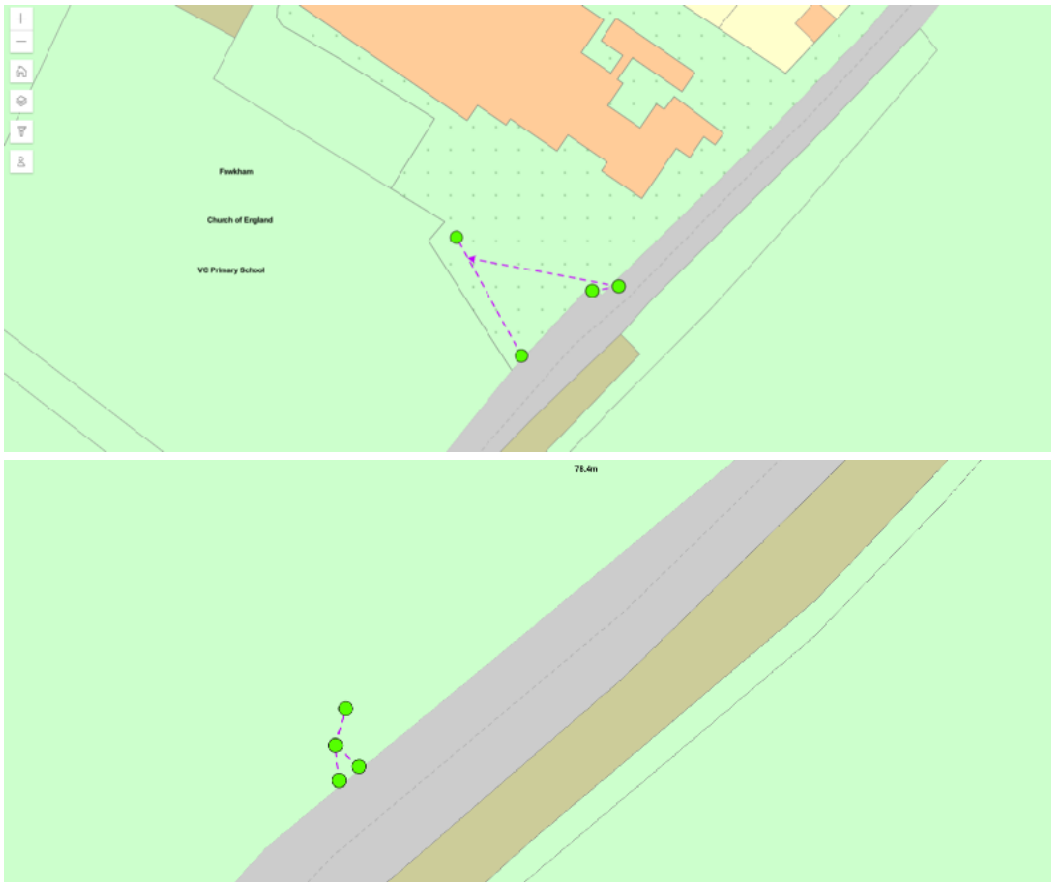
Valley Road, Fawkham (Outside School and just down from School) Outfall - Soakaway

- A soakaway system is located in a field to the south of the village school which receives water from two sets of drains (five in total) in the verge of Valley Road. Fawkham Parish Council advised the location of this soakaway to KCC in 2020, and, as it did not previously feature on KCC's system, it had not been maintained for many years. The system was subsequently cleansed and returned to operation in 2020. However, these drains frequently become blocked and overgrown with vegetation, and may benefit from the construction of a small wall behind them to retain the verge.

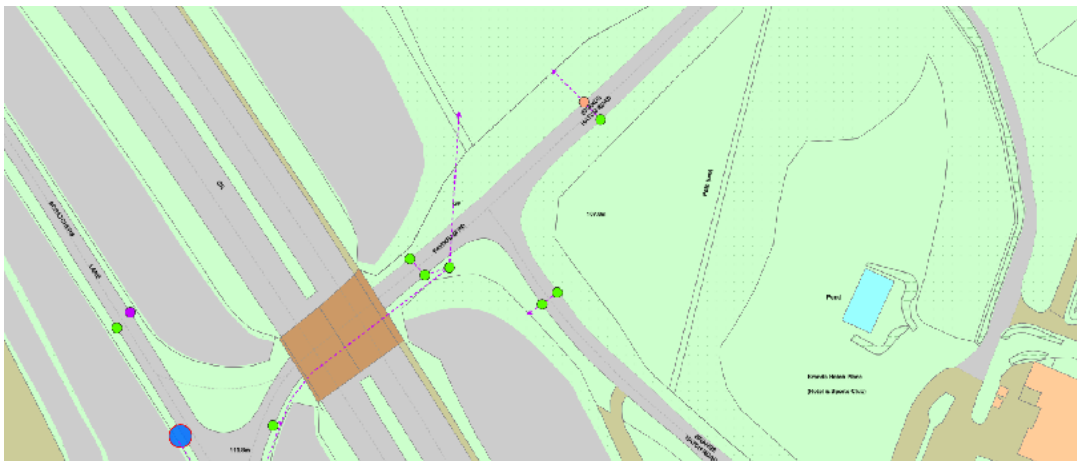
Brands Hatch Road/Scratchers Lane Outfall - National Highways Lagoon

- On Brands Hatch Road, close to its junction with Scratchers Lane, 6 drains lead to a purpose built lagoon at the southern end of the Parish, to the north east of the M20. The lagoon was constructed to serve the motorway and is owned by National Highways. This drainage system also includes drains on Scratchers Lane to the south west of the motorway, immediately outside the Parish boundary. Part of this system was not operating effectively for many years, resulting in Scratchers Lane becoming regularly flooded and impassable to many vehicles, causing problems with the access into the Parish via Brands Hatch Road (the main road along the valley floor). A damaged section of the system was identified and repaired in 2021/22 and the system's operation is being monitored by Kent County Council (KCC) to assess whether the repair has corrected the problem.⁹ From observations of the Neighbourhood Plan Steering Group, the flooding is less extensive, although the flooding here appears not to have been completely resolved.
